TECH TALK 0072
MES5MS ENGINE STRANGLER
POSSIBLE JAMMING ISSUE
5/2/2007

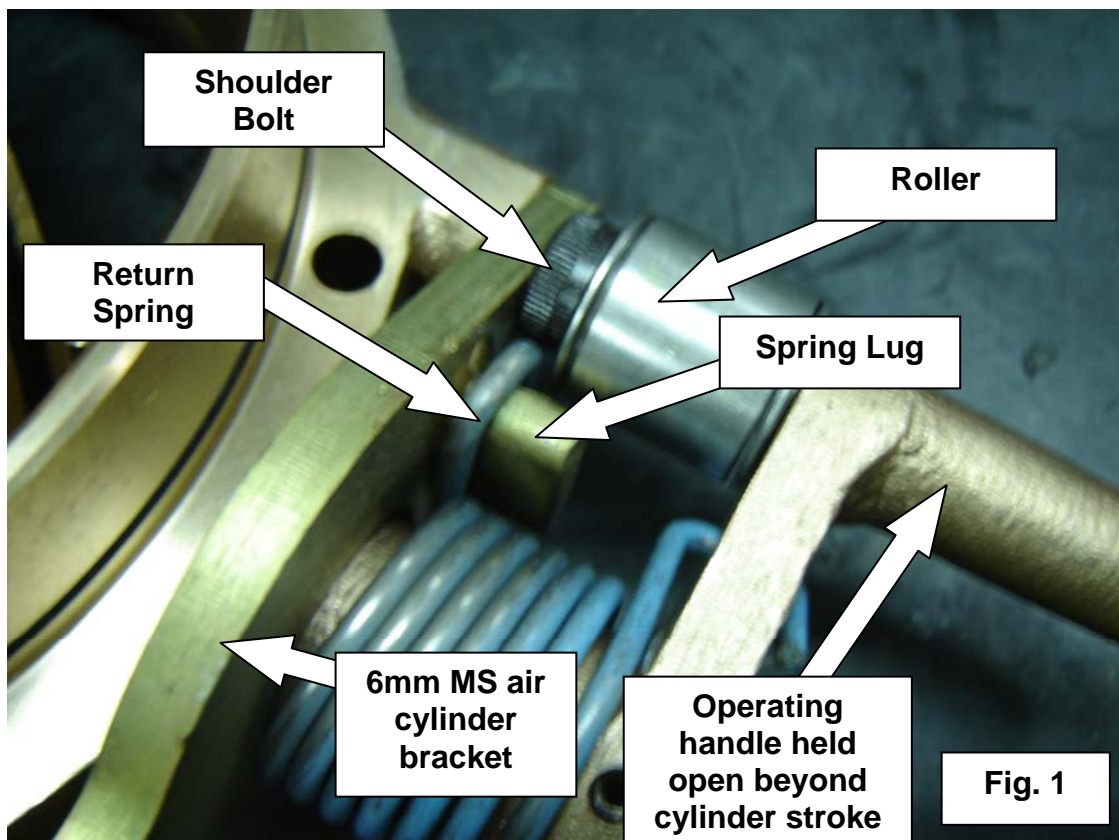
- The inertia of the air cylinder is enough to force the disk to continue to travel beyond the air cylinder stroke, causing the butterfly disc to open further than 180°.
- Several machining / fabrication processes are concurrently carried out to the limit of the allowable tolerances, allowing the shoulder bolt head to contact the return spring, and / or the roller to contact the spring lug on the air cylinder bracket, if the above scenario a) occurs. Refer to Fig1.

- a) Rotate the operating handle by hand in a clockwise direction until the roller and shoulder bolt travel past the spring lug as shown in Fig. 1, noting if the roller contacts the spring lug and / or the shoulder bolt head contacts the return spring. A very light contact is acceptable.
- b) Allow the handle to *slowly* return to its resting position, noting if the roller contacts the spring lug and / or the shoulder bolt head contacts the return spring. A very light contact is acceptable.
- c) If the contact is heavy, or if the handle jams open, the strangler will require modification. If there is any doubt as to if the contact is light or heavy, it is safest to presume the strangler will require modification.

By replacing the existing shoulder bolt with one 5mm longer and adding a new spacer bush, any chance of jamming is eliminated as the head of the longer bolt acts as a positive stop against the bracket edge. This positive stop restricts the roller from travelling too far beyond the cylinder stroke. This design has been successfully cycle tested by Liquip International and will be implemented on all new MES5MS stranglers.
